PICDEM™ Lab Development Board

PICDEMTM Lab Development Board Errata

The PICDEM Lab Development Board you have received conforms functionally to the information provided in the accompanying user's guide (41369**A**), except for the anomalies described below.

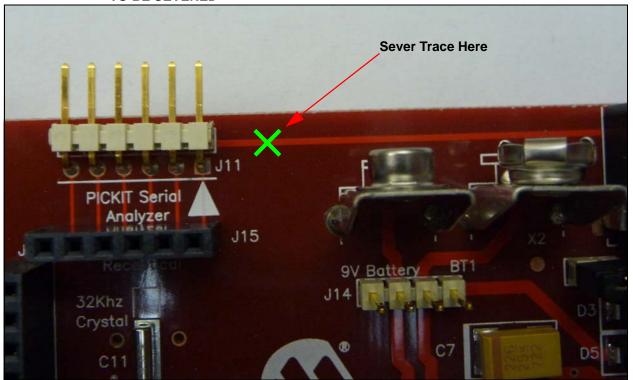
Issue: Damage can occur to the PICkit™ Serial Analyzer when the PICDEM Lab Development Board is powered by a 9V battery or 9V power supply.

Details: When the VDD connector on the PICkit Serial Analyzer header (J11) is connected to the 9V source on the board, significant damage can occur to the PICkit Serial Analyzer.

FIGURE 1: UPPER RIGHT CORNER OF PICDEM™ LAB DEVELOPMENT BOARD WITH TRACE TO BE SEVERED

To fix this issue, the user will need to sever the trace connecting the VDD pin of J11 to the 9V source

Locate the trace as indicated in Figure 1. Using a sharp tool, such as a craft knife, carefully cut the trace.

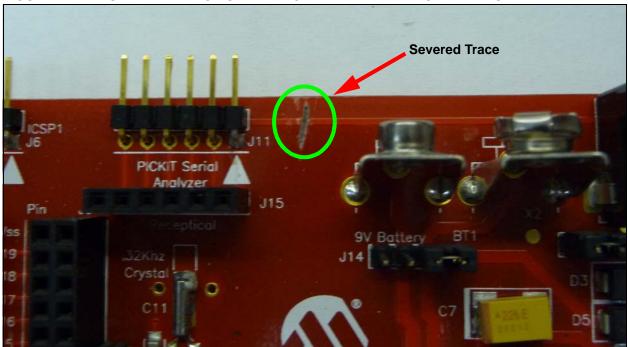
FIGURE 2: SEVERED TRACE ON THE PICDEM™ LAB DEVELOPMENT BOARD

The trace should now resemble Figure 2.

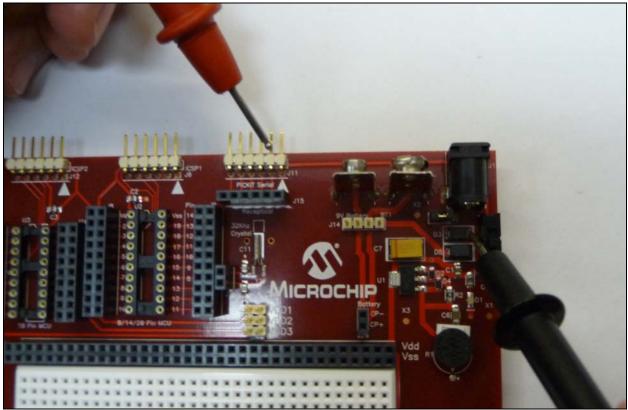
FIGURE 3: PROPER OHMMETER PROBE PLACEMENT TO CHECK THE OFFENDING TRACE

It is recommended that an ohmmeter is used to verify that the cut has severed the trace. To verify, connect one probe of the ohmmeter to the Vcc node and the second to pin three of the PICkit Serial Analyzer connection header (J11), refer to Figure 3. The Vcc node

can be found by placing one probe on the right most pin of either D3 or D5, found on the upper right side of the PICDEM Lab Development Board next to the PWR ON switch. A successful repair will indicate an open circuit.
