**MPLAB® PM3 ICSP MCLR/VPP Slew Rate Modification**

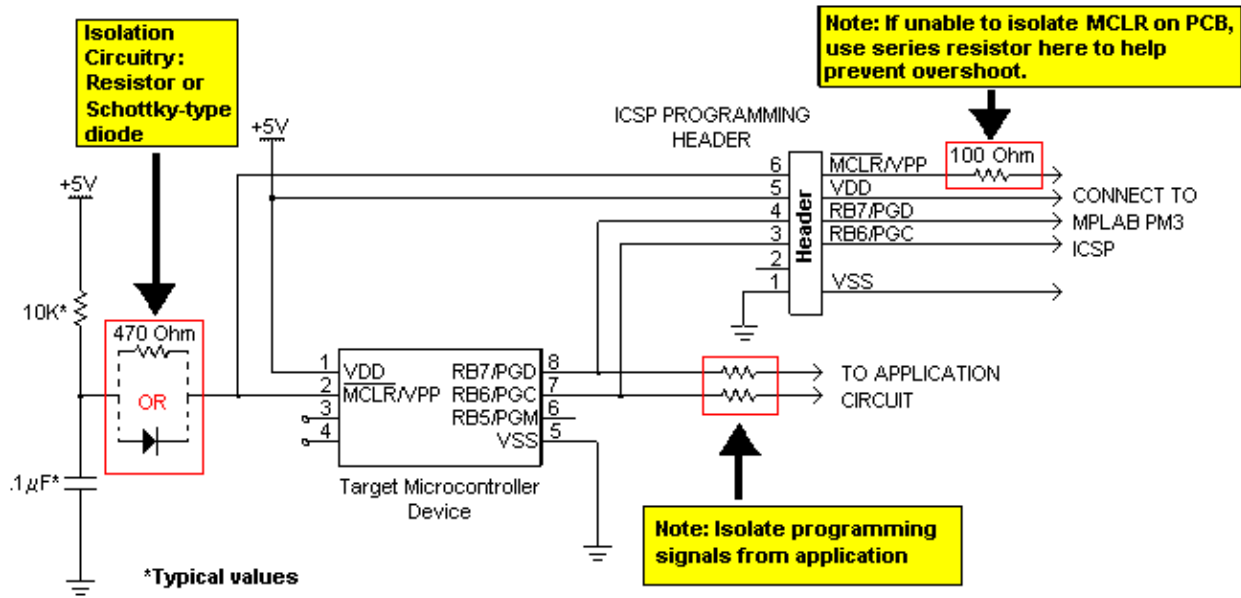
**Symptom:** MPLAB PM3, Assy# 10-00359-R9 or below without ECO 2937, may cause excessive voltage overshoot in applications with a capacitive load that has not been isolated from the MCLR/VPP pin of the PICmicro being used in ICSP mode. Depending upon the size of the capacitive load, this overshoot could cause excessive part stress as well as damage in some cases.

**Problem:** The rise time of the MPLAB PM3 high voltage VPP driver into a capacitive load, causes the voltage at the target microcontroller’s MCLR/VPP pin to exceed the maximum specified voltage.

**Solution:** A 100 Ohm series resistor may be placed between the MPLAB PM3 Device Programmer’s ICSP port MCLR/VPP line and the target’s MCLR/VPP line. See Figure 1 for details. If further problems exist, verify all programming signals meet the target microcontroller’s programming specification.
