# ENC424J600/624J600

## ENC424J600/624J600 Silicon Errata and Data Sheet Clarification

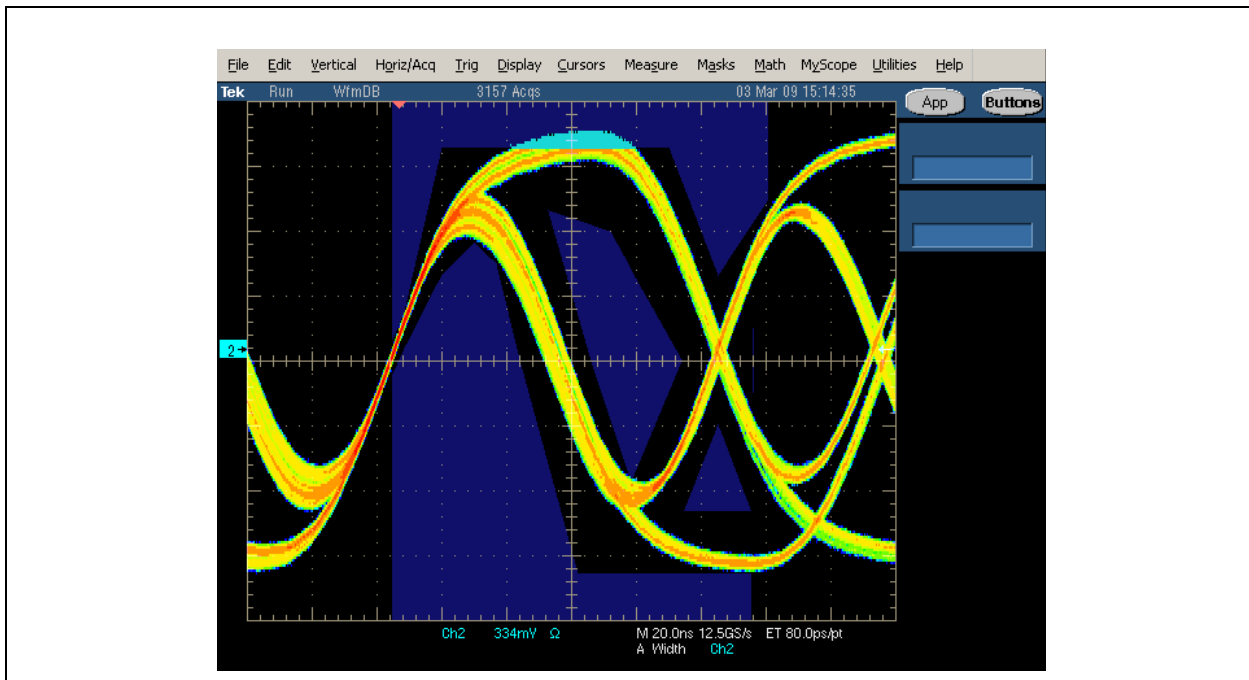
**FIGURE 1: 10BASE-T MAU EYE DIAGRAM**

When transmitting random data in 10BASE-T mode, the PHY transmit waveform slightly violates the MAU eye diagram keep-out zones specified in the IEEE 802.3™ Std. 2005, Section 14.3.1.2.1. Specifically, the waveform amplitude is slightly too high for '0' to '1' and '1' to '0' bit transitions when tested against the twisted-pair model, as shown in [Figure 1](#).

This issue applies only to 10 Mbps speed and is unlikely to cause compatibility problems in real networks. When terminated with a 100W resistor without the twisted-pair model, the transmit waveform stays within the amplitude limits of +2.2V to +2.8V and -2.2V to -2.8V required by the standard.

None.
